# Manhole Inspection Summary

Manhole # S41E\_\_035MH

Insp Date: **9/12/08 10:16 AM**

**Location** Address: **15 s caroline st**

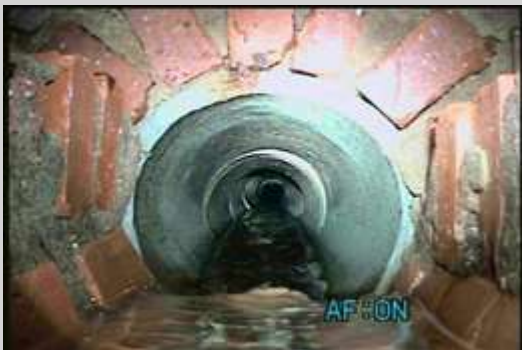
12 O'Clock Outflow

8 in. Circular Gravity Sewer  
Pipe Out @ 12 O'Clock

Pipe Material: **Clay** ☐ Pipe Lined

Invert Depth: 11.80 (ft.) Flow Characteristics: **Fast**

Deposits: ☒ None ☐ Mud ☐ Sludge ☐ Debris ☐ Grease

Infiltration: **None** Pipe Seal Cond: **Unknown**

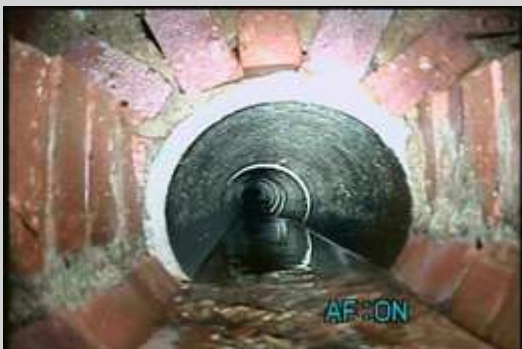
6 O'Clock Inflow

8 in. Circular Gravity Sewer  
Pipe In @ 6 O'Clock

Pipe Material: **Clay** ☐ Pipe Lined

Invert Depth: 11.60 (ft.) Flow Characteristics: **Fast**

Deposits: ☒ None ☐ Mud ☐ Sludge ☐ Debris ☐ Grease

Infiltration: **None** Pipe Seal Cond: **Unknown**

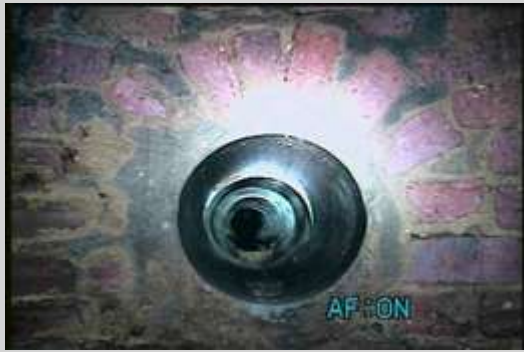
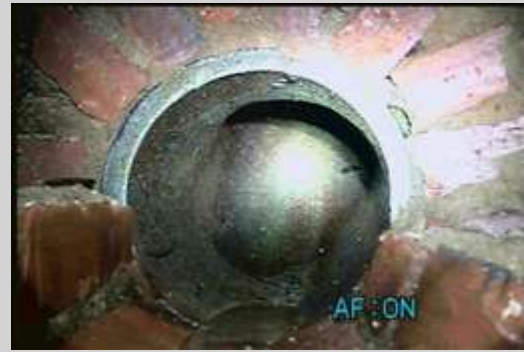
9 O'Clock Inflow

8 in. Circular Gravity Sewer

Pipe In @ 9 O'Clock

Drop In @ 9 O'Clock

Pipe Material: **Clay** ☐ Pipe Lined

Infiltration: **None** Pipe Seal Cond: **Unknown**

Drop Condition: **Open**
